ASPHALT PAVEMENT OXIDATION LEVEL MAPPING:AN ANALYSIS OF PIXEL DATA OF SATELLITE IMAGES USING ARTIFICIAL NEURAL NETWORK

A study dedicated on developing a software to determine the condition asphalt pavement with respect to its oxidation level using in-situ images through Artificial Neural Network. The software provides an efficient approach that may be used by the organizations associated with the maintenance and development of asphalt pavements. The study focuses on determining the asphalt oxidation level namely: fair, good, and poor through the use of Artificial Neural Networks(ANN). The researchers were able to develop a program using MATLAB for the application of the study. After using in-situ images for testing, the program were able to produce different output showing the pavements' condition either fair, good or poor.

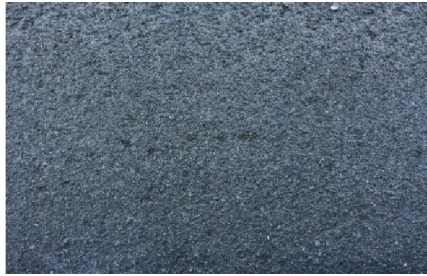
The image in Figure 4.1a shows an image which is directly used in the training of the neural network. This trial was intended to validate the integrity of network 3-10-3. In the figure 4.1b it can be noticed that almost all of the pixels are shown in green(Good condition) which is what is expected.

PIXEL TYPE	PERCENT(%)
POOR	0.0032%
FAIR	0.0000%
GOOD	99.9968%

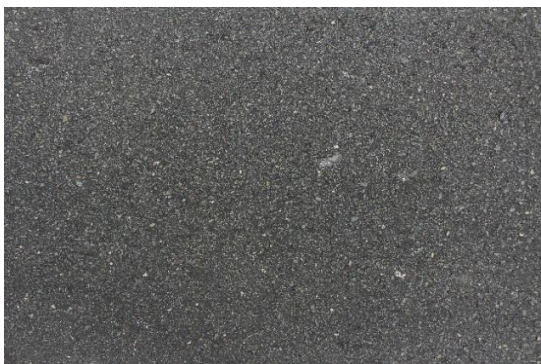
The on-site evaluation of Figure 4.2a, a road segment in President Jose P. Laurel highway in Batangas, is GOOD which coincide with its Image evaluation. By closely inspecting the asphalt road, it is evident that the aggregates used in the asphalt are only slightly visible and the asphalt binder used is still intact. However, by inspecting the processed image, it is clear that there are occasionally some aggregate(white spots) that are cleanly exposed, these spots can have an evaluation of POOR condition individually. Therefore, the result shows RED spots scattered evenly across figure 4.2b.

PIXEL TYPE	PERCENT(%)
POOR	4.0987%
FAIR	2.1216%
GOOD	96.7796%

Furthermore, The result of Image Evaluation relies on the Type of pixel that is most abundant in a particular sample. (e.g. figure 4.2b is evaluated as good since the percentage of GOOD pixels is higher among the other types)

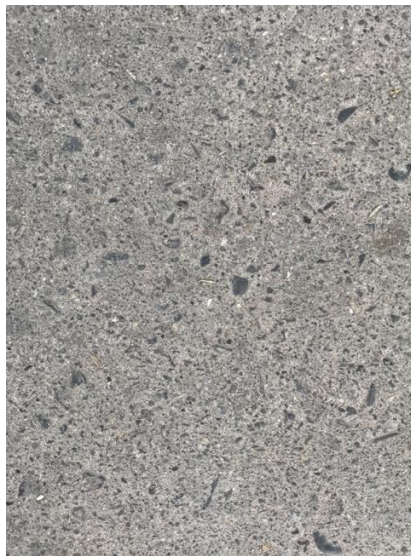
I. Strawberry Street, Barangay San Francisco, Mabalacat Pampanga

On-site evaluation: FAIR, Image evaluation: FAIR)

<i>PIXEL TYPE</i>	<i>PERCENT(%)</i>
<i>POOR</i>	<i>14.1118%</i>
<i>FAIR</i>	<i>83.3325%</i>
<i>GOOD</i>	<i>2.5557%</i>

It can be observed that the asphalt pavements presented in this section have the top layer of asphalt binder partially oxidized but not so much as to let the aggregates experience direct wear and tear due to traffic loads. This condition resulted in a much lighter reflectance as compared to the GOOD condition asphalt pavement in the previous section.

The resulting images produced by Matlab match the on-site evaluation of these pavements. By looking at the results, it can be seen that the majority of pixels in the processed images are Yellow in color (FAIR condition) thereby labeling these pavement images as FAIR condition.

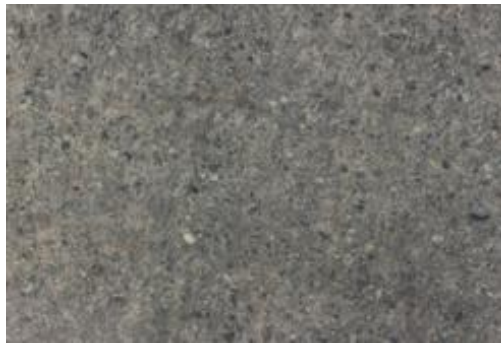
II. President Jose P. Laurel Highway, Batangas City

(On-site evaluation: FAIR, Image evaluation: FAIR)

<i>PIXEL TYPE</i>	<i>PERCENT(%)</i>
<i>POOR</i>	<i>5.7583%</i>
<i>FAIR</i>	<i>78.0216%</i>
<i>GOOD</i>	<i>16.2201%</i>

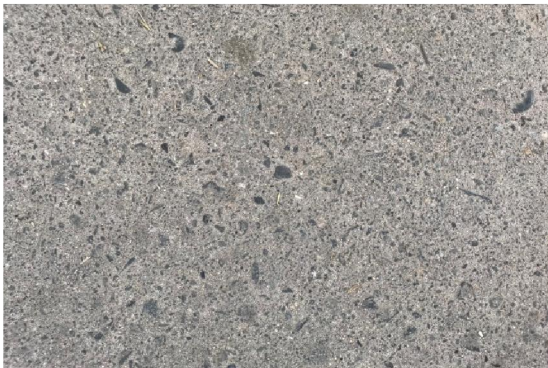
II. San Nicholas Highway, San Roque, Bamban, Tarlac

(On-site evaluation: FAIR, Image evaluation: FAIR)

<i>PIXEL TYPE</i>	<i>PERCENT(%)</i>
<i>POOR</i>	<i>14.1877%</i>
<i>FAIR</i>	<i>84.2914%</i>
<i>GOOD</i>	<i>1.5209%</i>

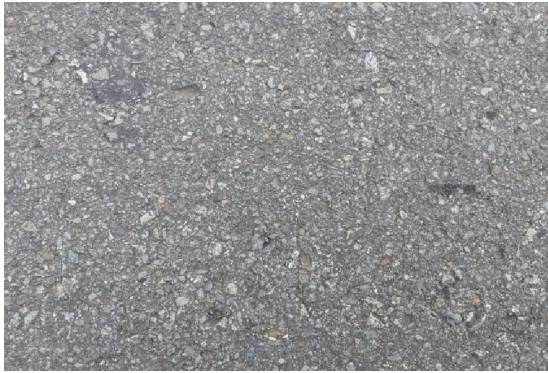
I. Tagaytay-Nasugbu Highway, Lipa, Batangas

(On-site evaluation: POOR, Image evaluation: POOR)

<i>PIXEL TYPE</i>	<i>PERCENT(%)</i>
<i>POOR</i>	<i>68.7701%</i>
<i>FAIR</i>	<i>26.7055%</i>
<i>GOOD</i>	<i>4.5244%</i>

In this section, it can be seen that the on-site condition of asphalt pavement is POOR due the evident direct wear and tear of the aggregate. The asphalt binder at the top layer of the asphalt pavement have greatly been removed making the aggregates directly carry traffic loads resulting in abrasion. Abrasions are represented by Light colored spots in shape of the aggregates used.
